MODIFICATIONS TO THE TUBE-LAUNCHED, OPTICALLY
TRACKED, WIRE-COMMAND MISSILE LAUNCHER FOR
THE BRADLEY FIGHTING VEHICLE SYSTEM

Report Number 98-165

June 25, 1998

Office of the Inspector General
Department of Defense

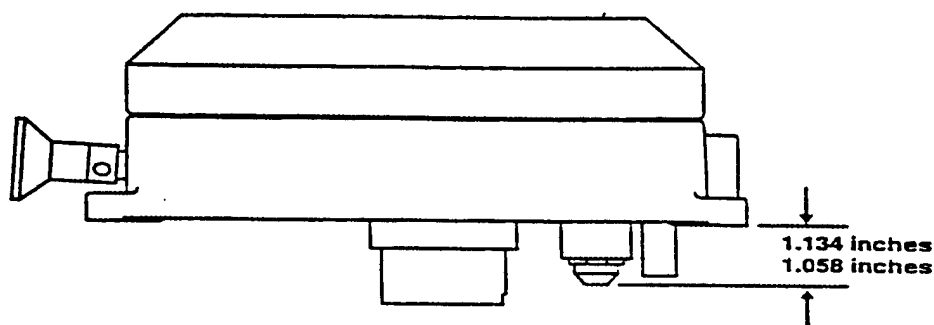
Figure 4. Holdback Pin Plunger Depth Specification

Alignment of Motor Stop Switches. The DMWR requires the gauge set to align and test motor stop switches S5 and S6. The S5 switch is the electrical limit switch for the extend function of the ACU motor. The S6 switch is the electrical limit switch for the retract function of the ACU motor. The S5 and S6 settings affect the distance that the holdback pin plunger and umbilical cable are extended when arming the system and retracted when disarming the system. The gauge set, specifically the S5 gauge assembly is required to ensure that the holdback pin plunger depth in relation to the ACU housing is between 1.058 inches and 1.134 inches, as shown in Figure 4, in order to satisfy design specifications.
